# Buysafe Home Inspections Ltd

Mr & Mrs Smith

123 Sea Road

11.00 am – 05 August 2009

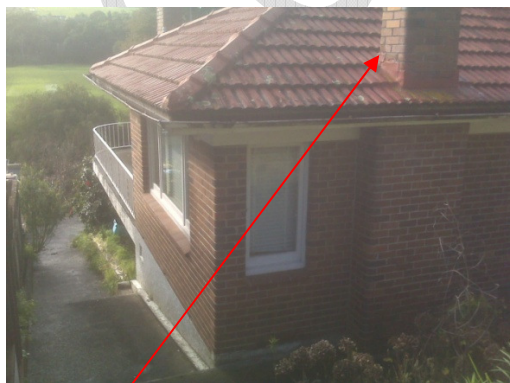
Flashing broken down

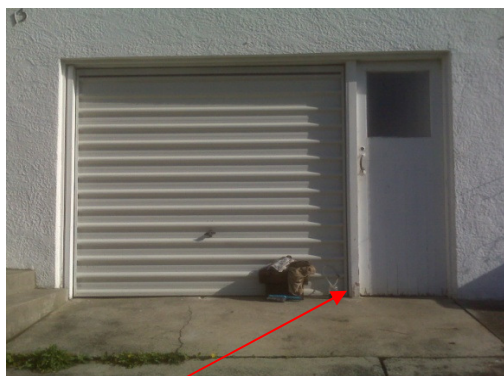
Garage side door rotting at bottom

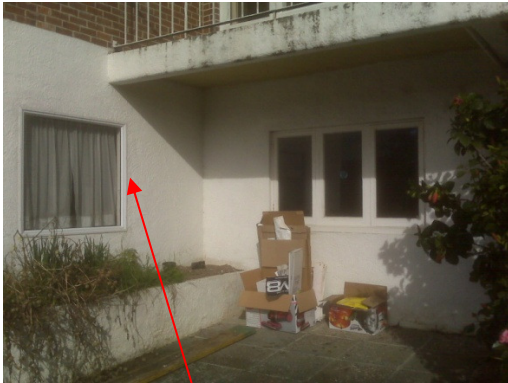
Odd window in aluminium

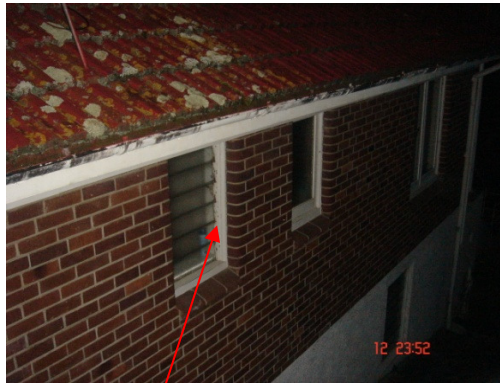
Toilet window glass louvers jammed

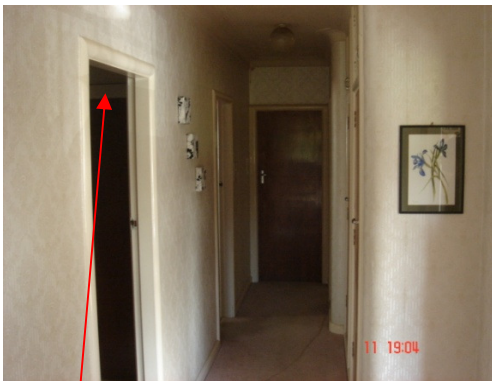
Office door requires adjusting

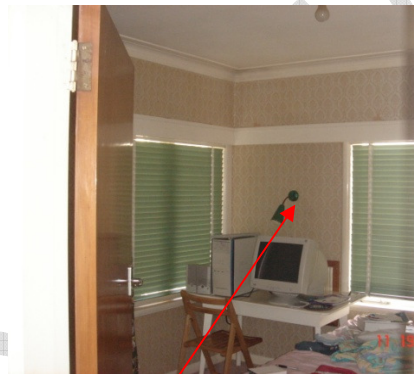
Bedroom light has no power to it

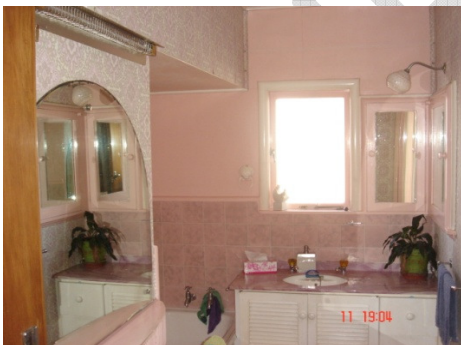
Loose tiles around window area

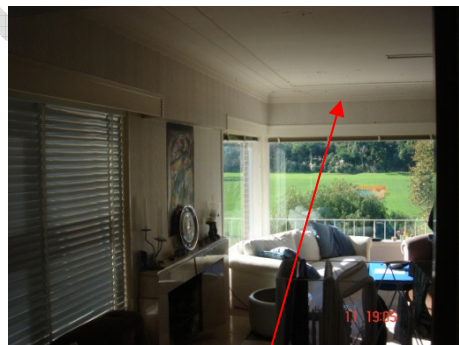
Ceiling paint flaking

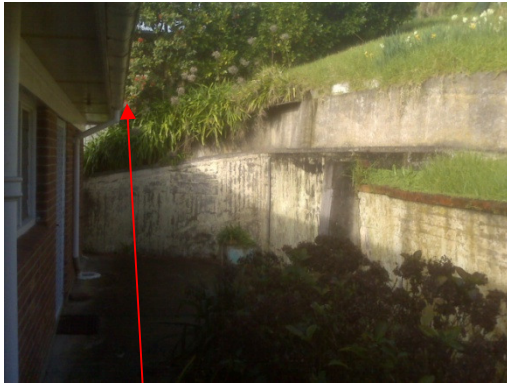
Spouting pipe Rusted away

EAVES		A	B	C	D	R	MR	
	Soffit		✓					
	Fascia		✓					
	Gutter			✓				
	Downpipes						✓	Rusted out

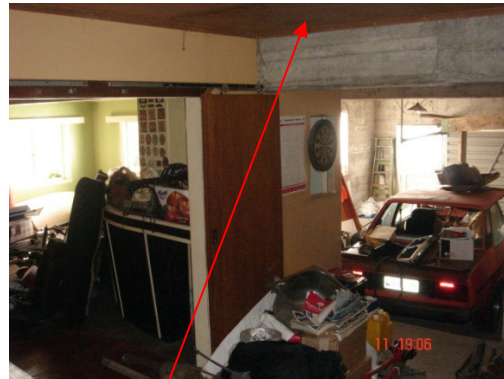
Garage ceiling is asbestos

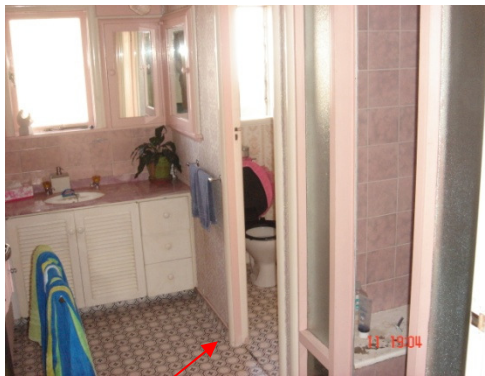
Bathroom Lino damp here

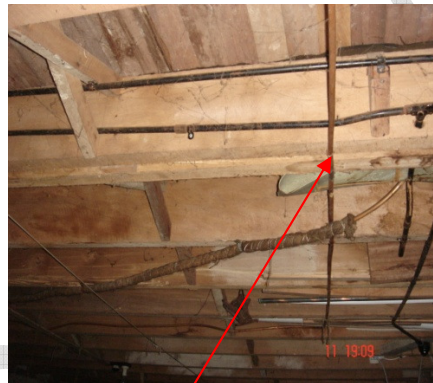
Copper hot water pipes need lagging

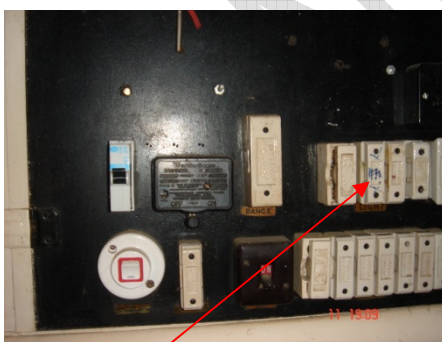
Switch board is very old & will  
Need updating – this can be costly.

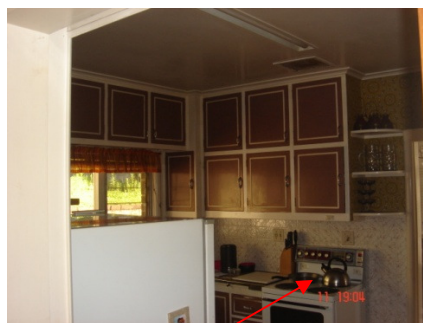
The oven rear elements do not work.
